**PRELIMINARY ASSESSMENT/  
VISUAL SITE INSPECTION**

**ACCRA PAC, INC.  
ELKHART, INDIANA  
IND 042 080 614**

**FINAL REPORT**

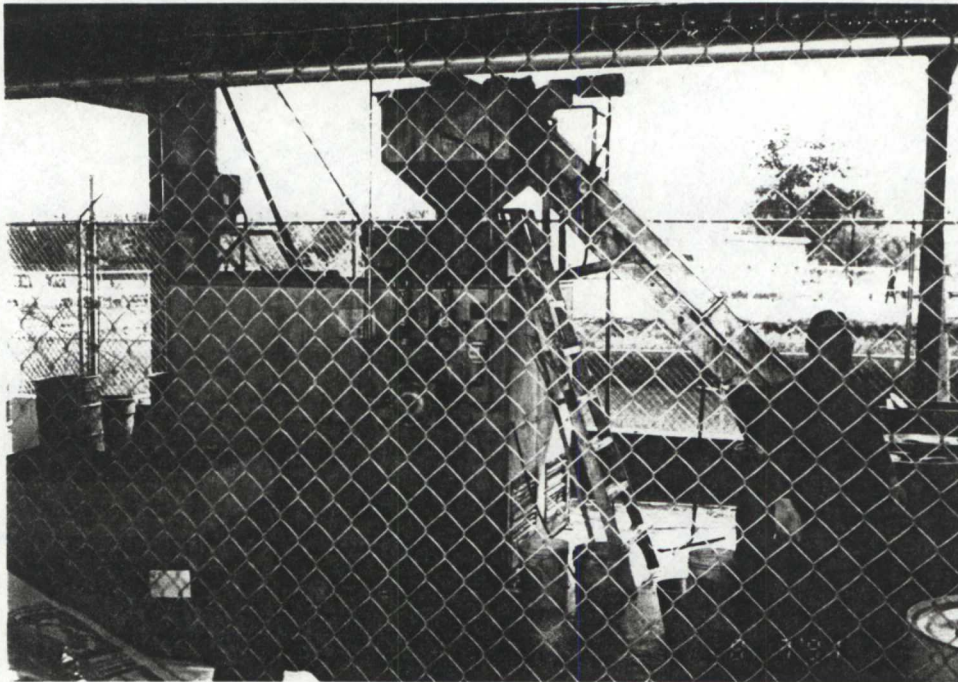
PRC noted 38 drums of hazardous waste and fifteen drums of nonhazardous waste being stored in the unit; they were in good condition and labelled with the accumulation start date and contents. PRC noted that the concrete below the shredder was wet.

Photograph No. 3  
 Orientation: East  
 Description: Aerosol can shredder unit showing wet concrete slab below.

**Recommendations:**              Air monitoring of the propellant releases should be conducted.

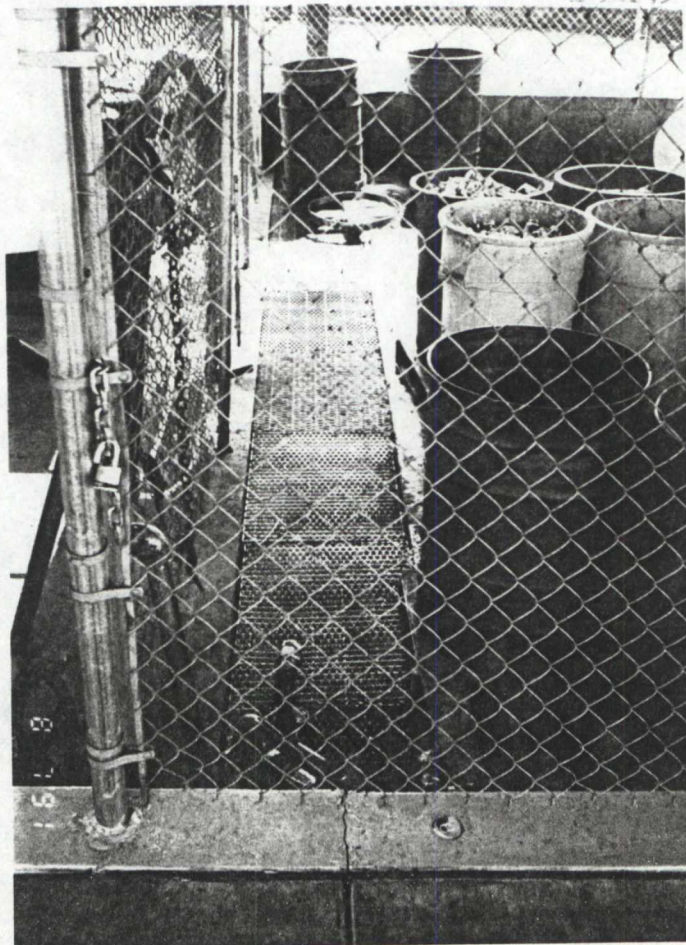
Photograph No. 4  
 Orientation: East  
 Description: Spills from the shredding process go into this trench drain and are pumped into 55-gallon drums.

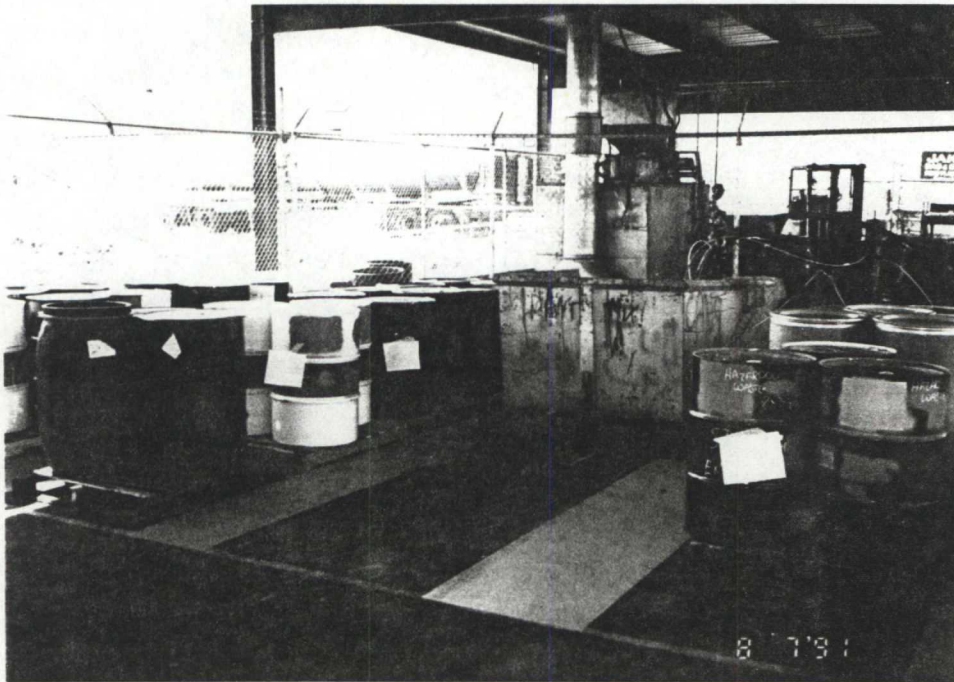
Photograph No. 5

Description: Hazardous waste drum storage area; the yellow line depicts the 50-foot minimum distance from the property line that all hazardous waste must be maintained within.

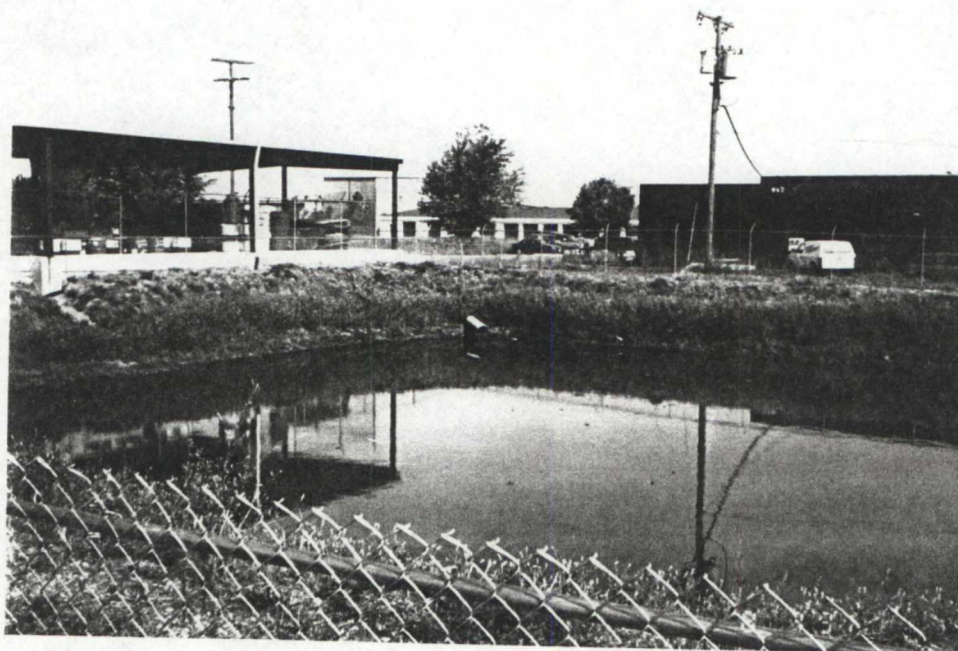
Photograph No. 10

The nearest surface water to Accra Pac is the St. Joseph River. The river is about 0.7 mile north of the facility. The facility grounds are not sloped, and the facility is not located in a 100-year flood plain. A retention pond that receives precipitation runoff from the facility grounds is located on the far north side of the facility adjacent to the aerosol can shredder unit (SWMU 2) (see Photograph No. 10).

Orientation: Northwest
